## **Clohamon Fish Release Observation Report**

**6<sup>th</sup> August 2013**

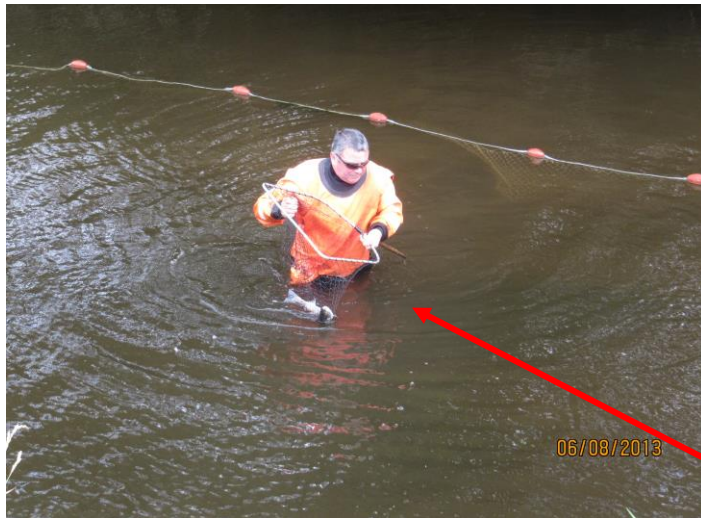
5.

**Image 5:** View of IFI operative netting a small salmon from within the driftnet zone.

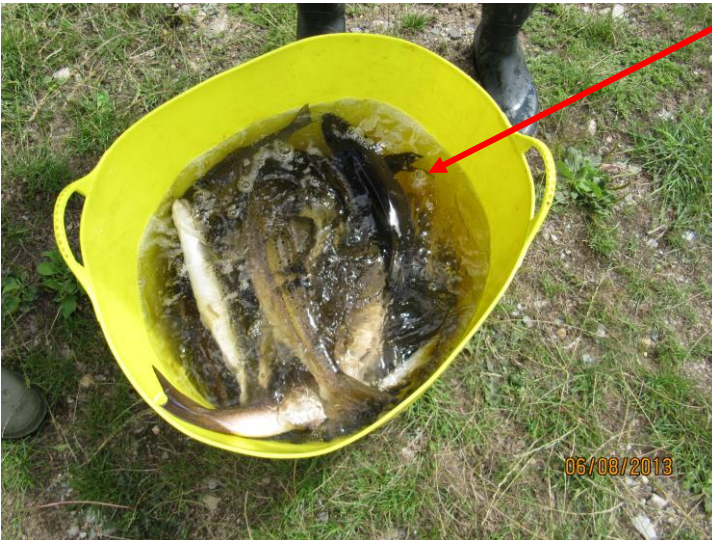
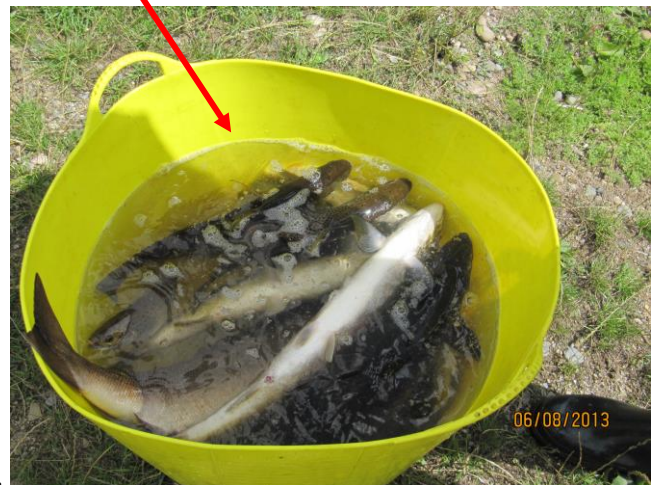
**Image 6/7:** View of some of the many sea trout and salmon captured and immediately transferred to the main river channel. (The water level was falling steadily at this stage)

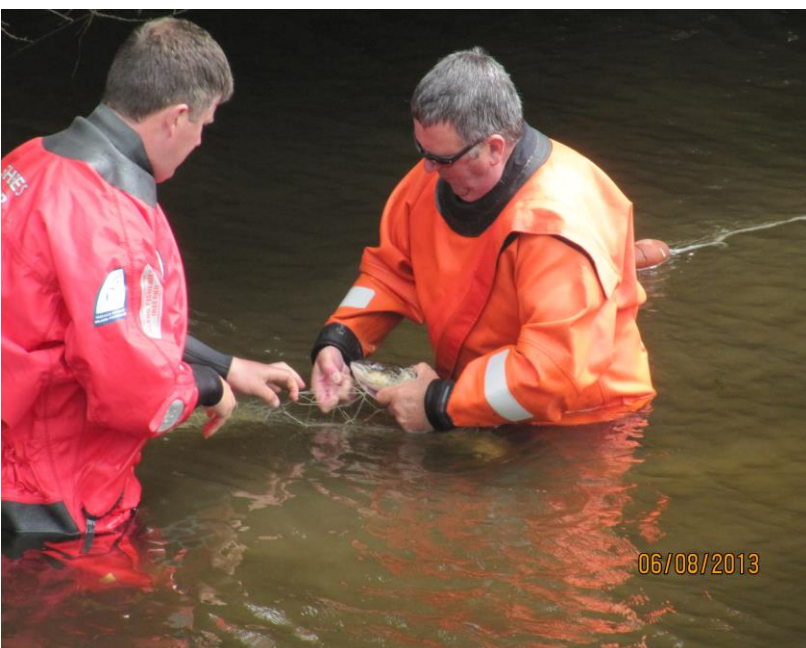
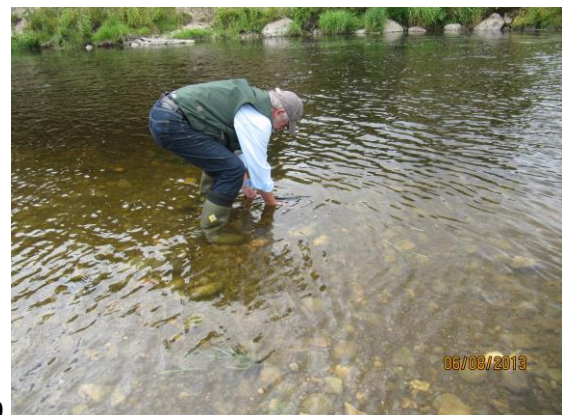
**Image 8/9:** Further view of IFI team releasing a salmon from the drift net. 'Yours Truly' releasing a salmon in the main river channel.

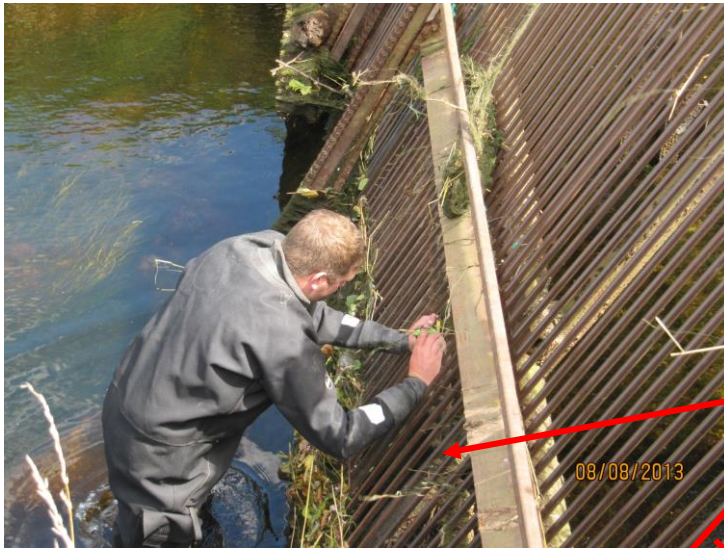
13.

Following a further request by IFI the following day to suspend turbine activity, only then the true cause of the problem of fish migration into the millrace was identified. It was clearly evident that the lower steel grate bars in some instances were broken or missing in addition to gaps in the adjacent stone supporting wall, thereby allowing free passage of fish into the millrace zone, This issue is clearly illustrated in the photo images below.

**Image 13/14/15:** View showing IFI operative measuring gaps between the steel bars of the grating. Some gaps found were in excess of 200mm and averaged 75mm.

*It was noted during this visit that 75mm spacing of steel bars will not prevent fish under 1.8kilo (4 lb) from entering the millrace stream.*

Further images of remedial works with new steel bars welded in position to prevent passage of fish.

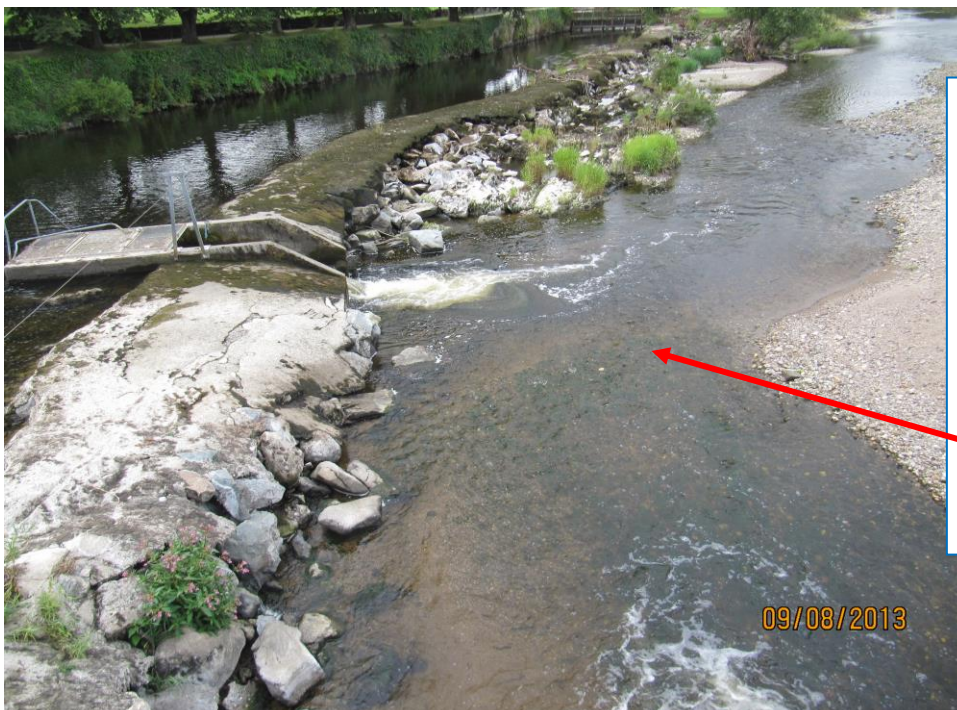
**River Flow:** It was clearly evident that once the millrace turbines were switched off, a significant quantity of water now diverted, freely flowed over the adjacent weir. As the river gauge downstream indicated a level of two inches (very low summer level) during the events, it is clear that any water abstraction or turbine activity during summer drought conditions seriously impedes fish and other species migration passage over the weir.

**Image 15:** View of the weir on the morning of the 9<sup>th</sup> August after the turbines were in full operation again. This view shows a disturbingly low flow level in the main channel with no water at all, flowing over the weir.

The water level was later measured indicating a depth of 150mm at the tail of the outflow from the 'Denil' fish pass.

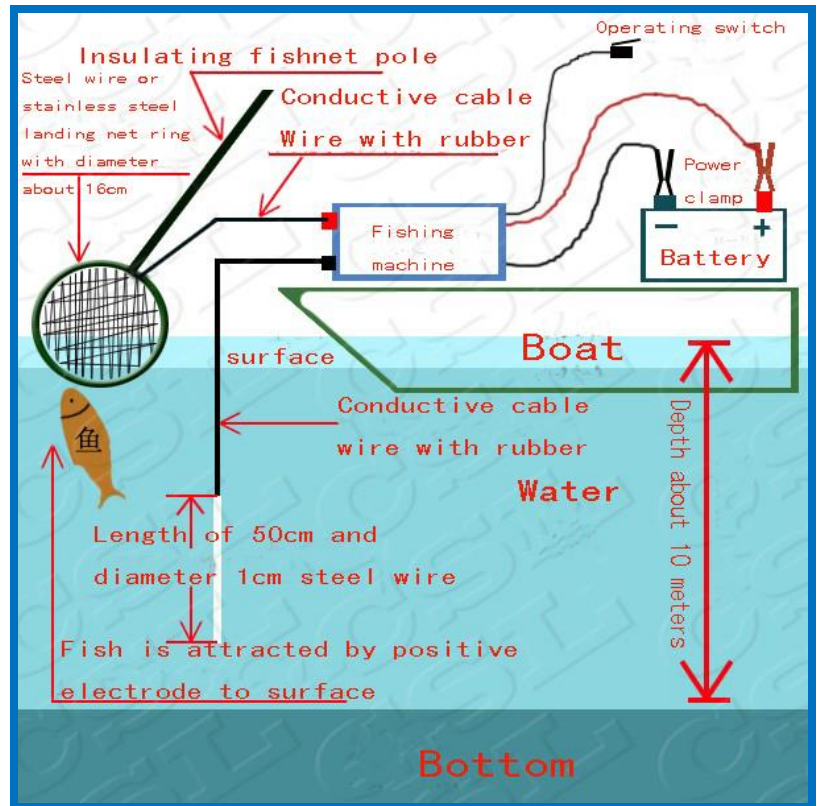
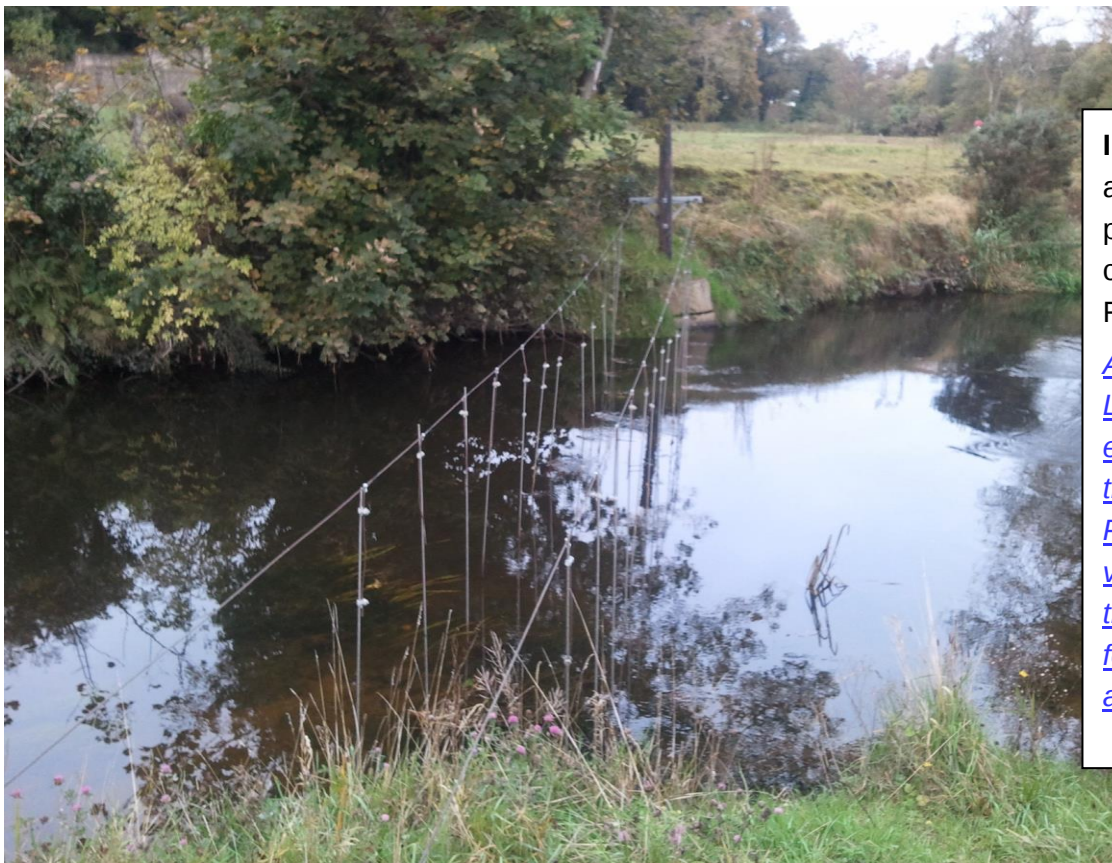
**Image 17:** Typical image of an electro fish barrier in position using a light electrical current as supplied by Electro Fishing Services Ltd.

*At Electro Fishing Services Ltd we use projected field effects to frighten the fish, we try not to shock or stun them. Projected fields reduce the voltage gradient and extend the field by up to 1m. The fish feel the field a long way out and keep clear.*
